NATIONAL PROGRAM FOR INSPECTION OF NON-FEDERAL DAMS  
FORGE POND DAM (MA 00.) (U) CORPS OF ENGINEERS WALTHAM  
MA NEW ENGLAND DIV APR 79

April 1979

FORGE POND DAM

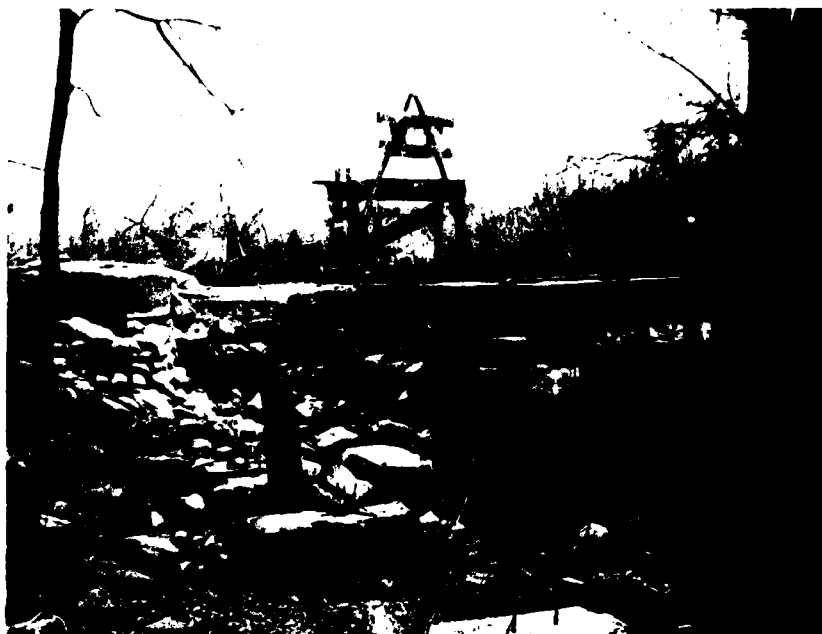
Several cavities were observed in the stone wall on both sides of the auxiliary outlet structure. The stone masonry is mostly dry joint with vines growing in it. The cavities were probably formed when the water flanked the structure and undermined loose stone. The largest cavity, 18 inches deep was observed on the right side of the auxiliary outlet structure. At this same location, it appears that precast concrete vehicular stop logs were recently placed to fill a gap in the wall.

**NO. 4 VIEW OF UNDERMINER TRAINING WALL AND CONCRETE APRON ON RIGHT SIDE OF AUXILIARY OUTLET STRUCTURE**

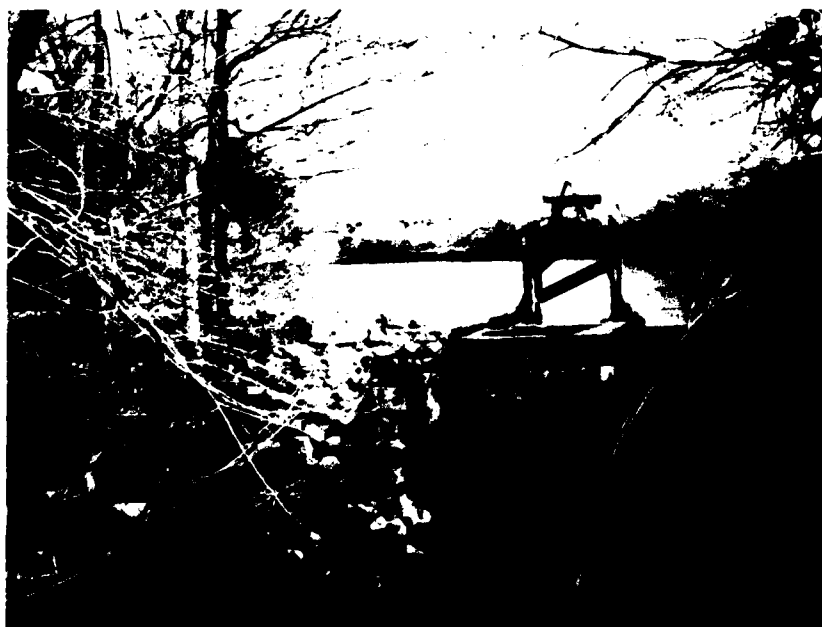
The auxiliary outlet structure is also in poor condition. It consists of a concrete intake structure leading to a 54-inch diameter outlet pipe. The remains of a wooden platform apparently constructed for a slide gate is located above the intake structure. The slide gate and mechanism are no longer present. The concrete sidewalls were cracked, spalled, stained and deteriorated. The stop log keyways on the inside of the concrete sidewalls are deteriorated. The concrete walls appear to have been placed directly on a dry joint stone wall, as cobble-size stones are embedded at the base of the sidewalls. Water was observed leaking between the right sidewall and the bottom of the dry-stone masonry section of the embankment. The downstream end of the intake structure is boarded up and covered with a sheet of rubber. However, there is a small amount of leakage into the

**NO. 6 VIEW OF AUXILIARY OUTLET STRUCTURE  
FROM FORGE ROAD BRIDGE**
